STAR 009

V2 – December 2014

**Winter Operations – Tailplane and
Engine Fan Blade Icing**

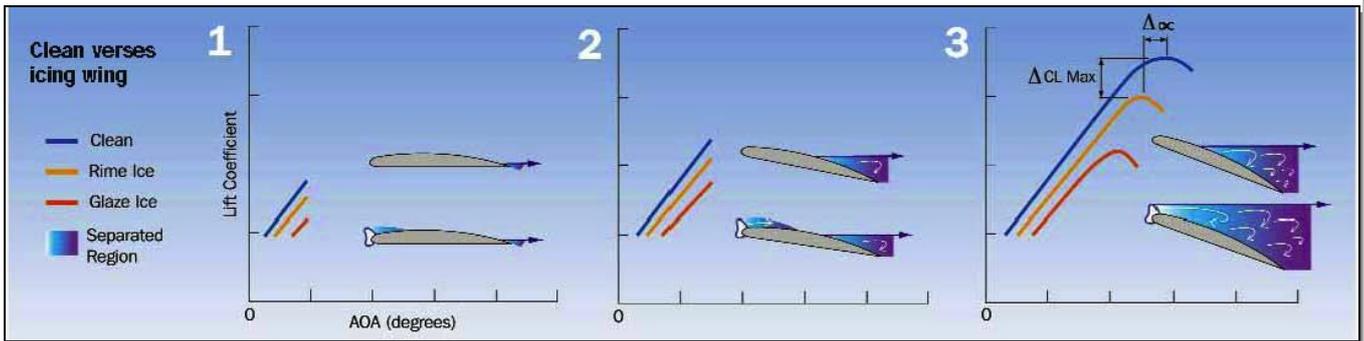
Asymmetric ice shedding from propellers or jet engine fans can also give rise to vibration.

- With ice accretion on the wing leading edges, the mechanism of stall development remains the same but starts at a lower AOA and therefore higher speed. In addition the airflow does not have the same level of energy around vortex generators (if fitted) for them to delay progression of the stalled area as effectively as on a clean wing.

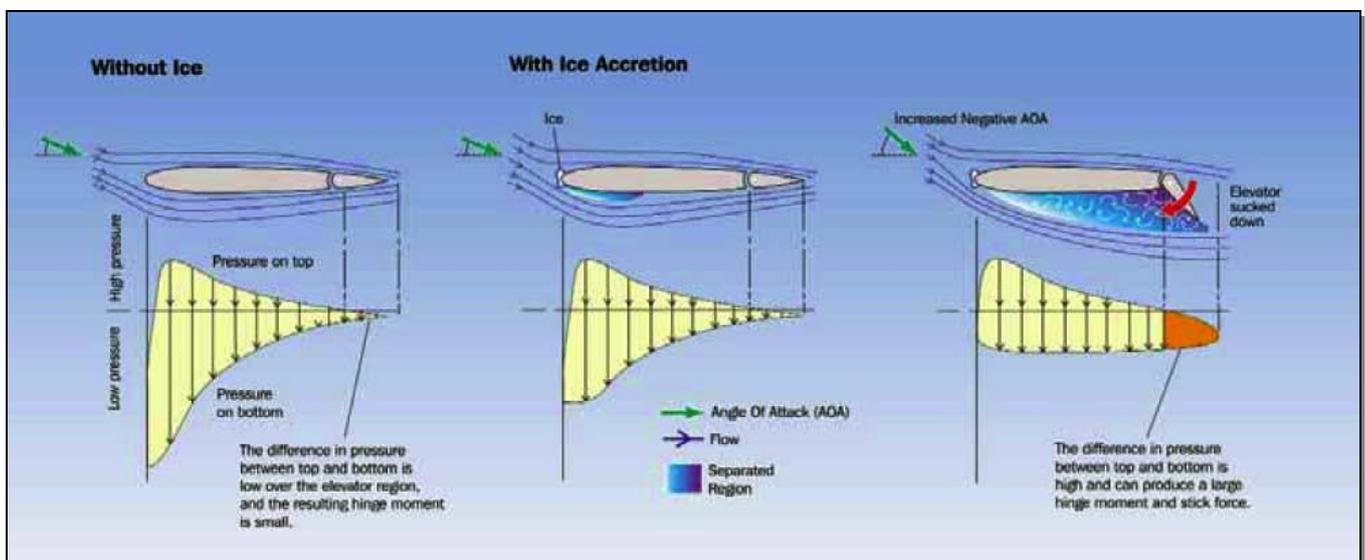
- ➔ Normally, the tailplane creates a force (lift) in the downward direction to balance wing and fuselage pitching moments. Under normal conditions, without ice accreted, aerodynamic pressures above and below the elevators are roughly equal and thus create no significant control surface hinge moment (see illustration below).

- With ice accreted on the tailplane, flow separation may develop on the lower surface, which will limit the maximum amount of downward lift the tailplane can generate and cause the tail to stall at a lower AOA.

- ➔ In the worst case, the elevator would be forced to the nose down stop if unrestrained, and the aircraft would respond accordingly by pitching nose down, often rapidly. This would be in addition to the aircraft's natural nose down pitching tendency as the tailplane loses downward lift effectiveness, and could require an extremely high pull force on the control column to recover.

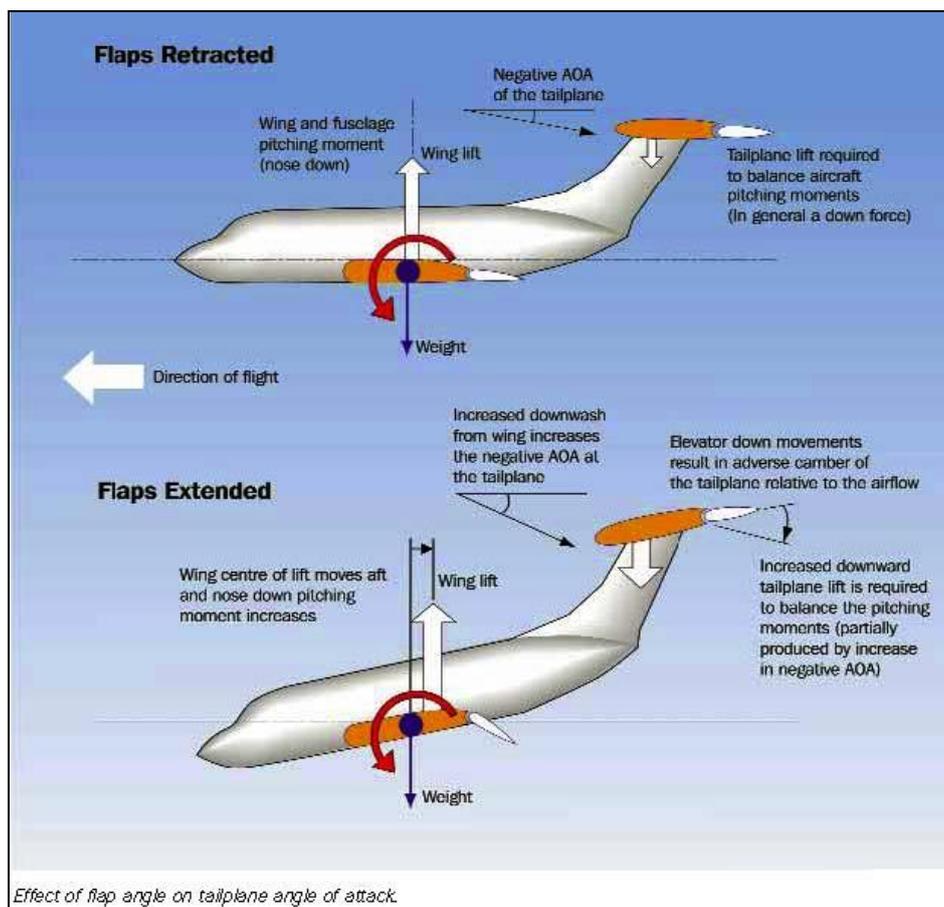
- ➔ Extending the flaps increases the airflow downwash angle from the wing and the tailplane negative AOA (see figure below). For a given flap setting, the AOA on the tailplane becomes more negative with increasing speed because of the reduced AOA of the wing (more nose down, more tail up). Therefore, at higher flap angles and airspeeds the wing stall margin is increased, but the tailplane stall margin is further reduced.

Source: BAE Systems 'Think Ice! 2007'
